## Using Data Manager® 2000 to remotely diagnose gas compressor rotating stall

by **Sebastiaan Teeling**  
Machinery Vibration  
Specialist, Machinery  
Management Services  
Bently Nevada Corporation

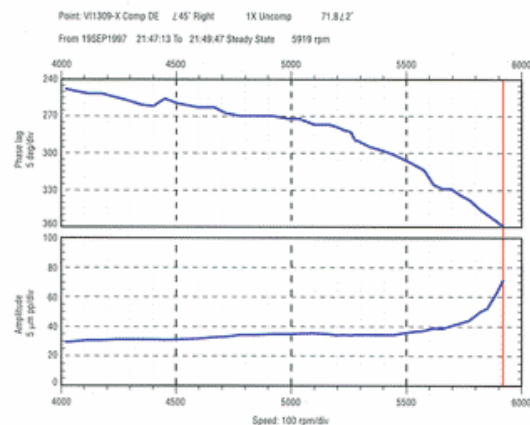
vibration recorded during the start-up, moments before the trip (Figures 2 and 3), show that, during the load increase on compressor B, vibration levels had increased significantly, along with a phase change of approximately 90°.

Figure 2. Bode plot of 1X amplitude and phase during startup.

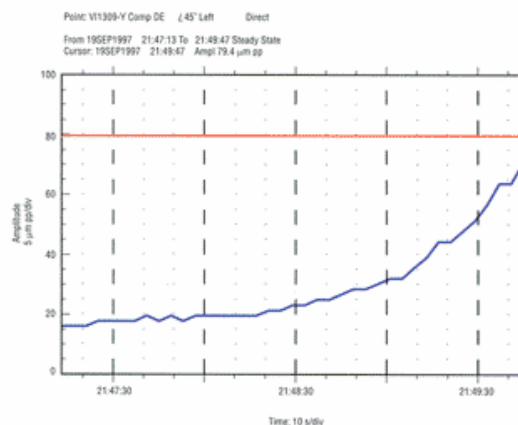
Figure 3. Trend plot of direct vibration amplitude during startup.

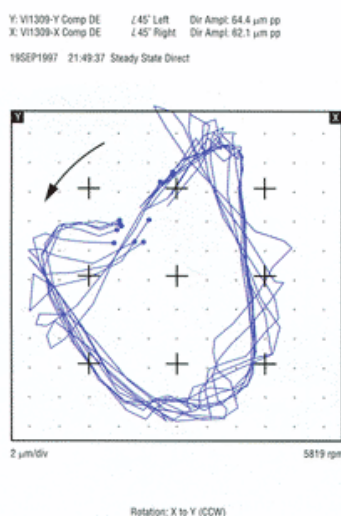
A closer inspection of the vibration data taken during the runup showed that, as the 1X vibration amplitude increased, the shape of the orbit changed into an abnormal,

almost square, form. The orbit plot represents the movement of the shaft centerline (if the shaft relative proximity transducer is not moving). One explanation for these square orbits is that the vibration probes were moving as well. MMS, therefore, advised the operator to inspect the casing foundation bolts. These bolts were loose! The manufacturer was called to inspect the unit, as it was still under warranty.

Figure 4. Changing shaft orbit pattern at compressor drive end.

After the OEM had properly realigned the compressor and cor-

rectly tightened the foundation bolts, the unit was ready for a restart. This time, Bently Nevada MMS Engineers were online via modem during the startup. The unit ran up to nearly 7000 rpm without any problems. At 7200 rpm, though, the unit suddenly experienced high vibration amplitude again. Within 2½ minutes, as the speed continued to increase, the vibration amplitude increased from 10 to 110 mm pp, and the unit tripped. At first, operations suspected that the compressor's problem hadn't been solved.

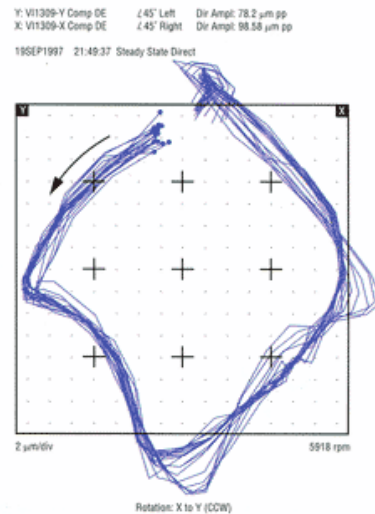
Figure 5. "Square" shaft orbit at compressor drive end just before the trip.

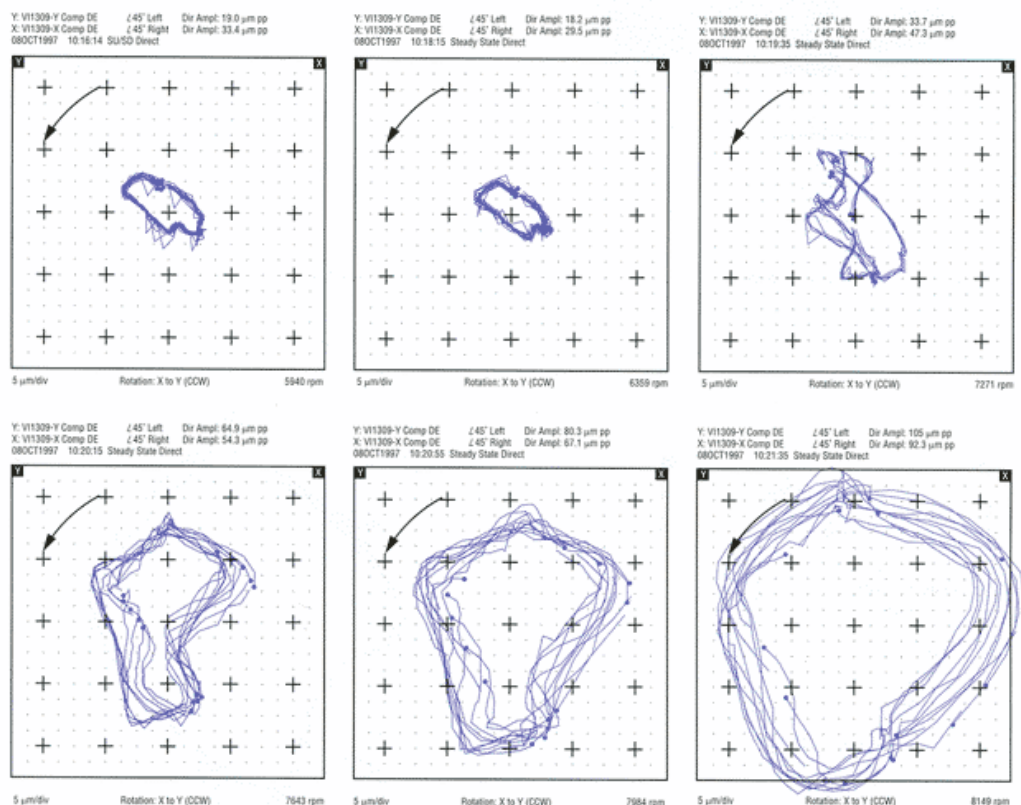
However, machinery data from the DM2000 system showed that the orbit shape and Keyphasor® dot pattern (Figure 6) differed substantially from the earlier orbit, and the machine clearly had a different problem.

The vibration data up to 7000 rpm showed a normal 1X amplitude and phase behavior. After that, the machine's vibration response became unstable, and a subsynchronous vibration component dominated the orbit.

Figure 6. The orbit patterns during the startup of the compressor. At 7271 rpm the orbit shape is dominated by a subsynchronous vibration component, caused by circumferentially propagating pressure waves in the impeller.

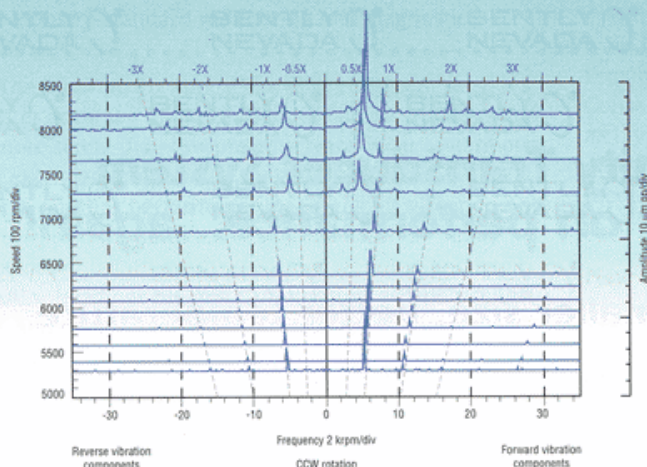
The vibration full spectrum cascade plot (Figure 7) shows that this

subsynchronous component is forward and at approximately 0.65X running speed.

The most logical explanation for subsynchronous vibration at 0.6X-0.8X rotative speed on centrifugal compressors is rotating stall. Rotating stall is an instability of the coupled aerodynamic/mechanical system resulting in forward whirling of a rotor at a subsynchronous frequency, which tracks the rotative speed. It is caused by boundary layer separation in the compressor which results in partial flow reversal in the diffusers or impellers and circumferentially propagating pressure waves.

**Figure 7.** The full spectrum cascade plot clearly indicates that the subsynchronous vibration is tracking running speed at 0.65X and is forward in precession.

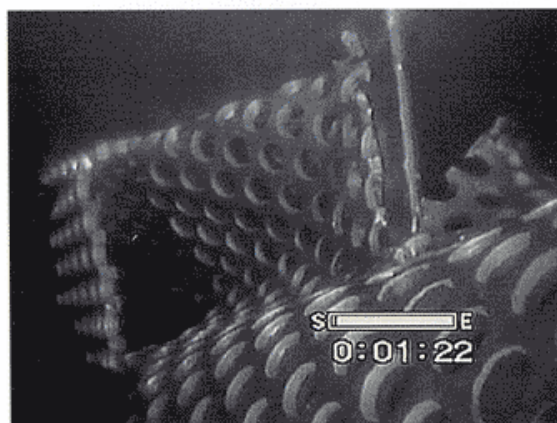
After opening the compressor inlet strainers, it was seen that large parts of these filters were ripped off and missing. It was concluded that these parts had been sucked into the compressor, so a borescope investigation was performed. As soon as the camera entered the compressor inlet, a large piece of the filter was visible, folded around an inlet guide

vane (Figure 8). This piece of filter, which clearly blocked a large part of the compressor inlet, was the reason for the rotating stall at the impeller. Although the compressor inlet and outlet pressure and flow conditions indicated that the unit was far from a surge condition, the filter part affected the inlet flow to such an extent that the operating point in the impeller moved close to the surge limit, and boundary layer separation took place. This caused the characteristic high amplitude, subsynchronous vibration.

**Figure 8.** A borescope picture of the compressor inlet eye shows a large piece of the inlet strainer folded around the inlet guide vanes and blocking the compressor inlet eye.

Further inspections revealed that all the inlet filters of Units A and B had also partially or completely disintegrated. To prevent further damage, the operator decided to remove these filters.
